## Retrofit Centennial Natatorium

Case Study Benefits: Avoid Structural Decay Lower Operating Costs Enhance Indoor Air Quality Reduce Condensation

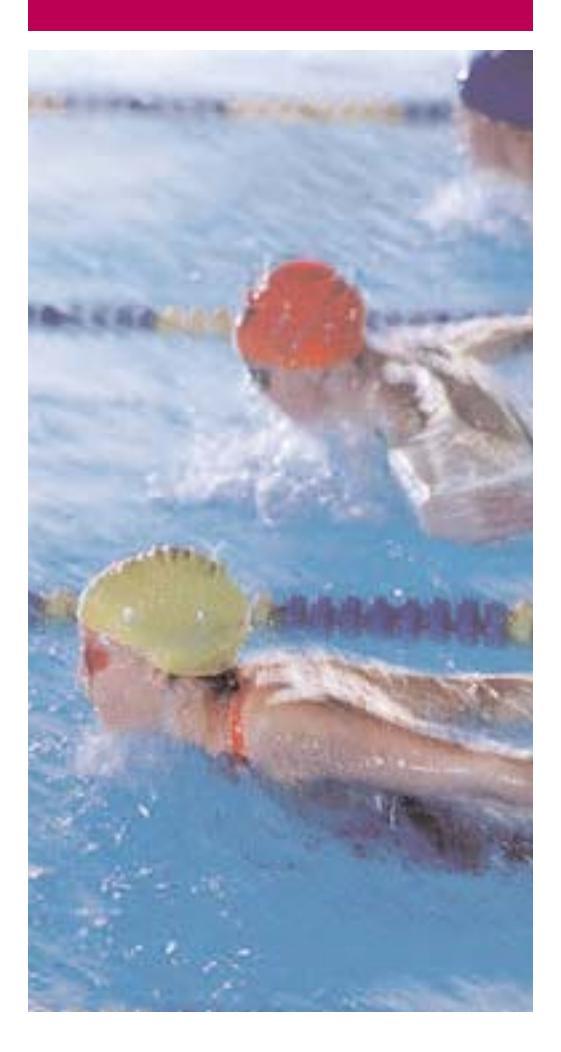
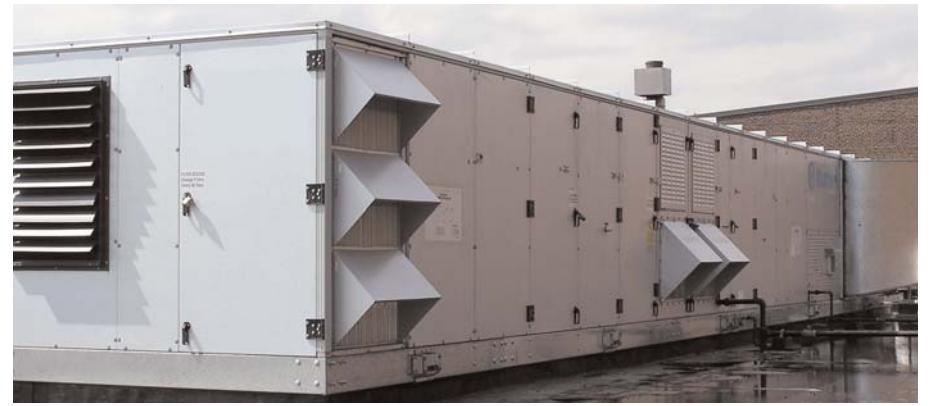
The AM20-1300G at Centennial is the first Munters' unit for a large scale pool application to be sold in Canada.

The AM20-1300G uses a desiccant wheel for dehumidification and heat recovery to pre-treat the outside air. The unit also has post heat and cooling. It is the first Munters unit for a large scale pool application to be sold in Canada. EI Solutions jumped at the opportunity to open the window to natatoriums. As Art Doramajian of EI Solutions stated, "It was the right time to make the move into the pool market. Centennial had an older technology system that wasn't working- we offered a product with lower operating costs and greater reliability."
